## Michigan LID Case Studies

### Pokagonek Edawat Housing Development

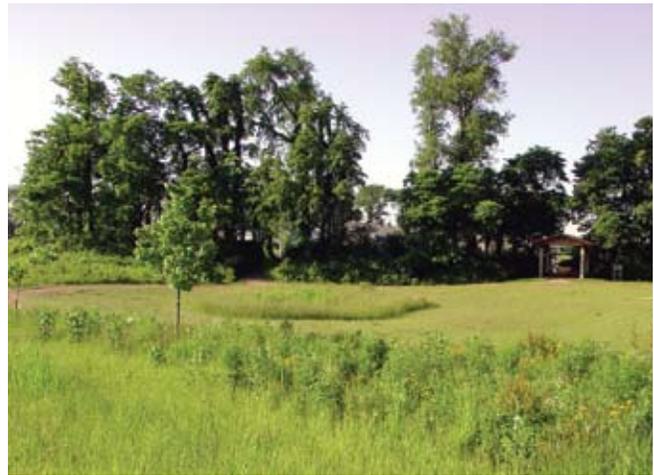
*Bioswale*

The first phase, or neighborhood, of the development includes 17 homes. Each home has at least one rain garden that accepts roof-top drainage. During the design process, the native topography of the site was retained as much as possible to preserve the natural drainage. Any stormwater runoff generated from the neighborhood is managed by the depressions where infiltration capacities have been augmented by native vegetation to create bioswales.

For the bioswales, a combination of plug placement and seeding with a warm season grass drill was used, along with an initial fertilizer application. A mixture of warm season grasses and forbs were selected for the bioswale vegetation. Initial maintenance largely included watering and weeding. Weed management during the first year included mowing. Current maintenance activities include prescribed burns and selective mowing. All maintenance is performed by the Pokagon Band Hous-

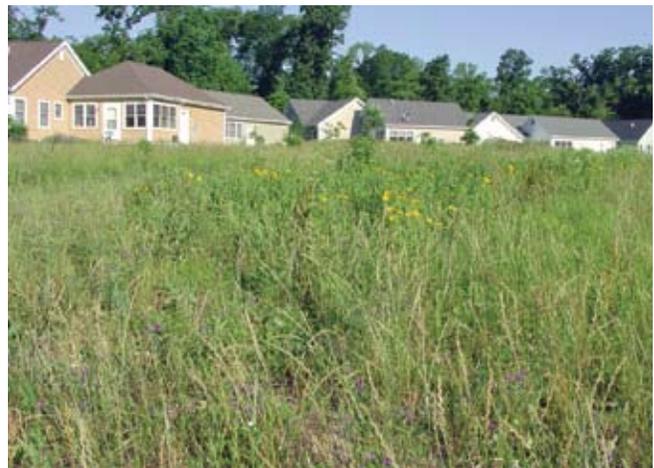
*Clustering homes*

The housing units have been clustered in loops following the site topography with 17 units in the first phase and 16 units scheduled for the second phase. Clustering reduced development costs by shortening roads and utility runs. Smaller lots have reduced lawn and yard maintenance. Clustering also allows for shared bioswales to be established among the buildings, helping to manage runoff. The footprints of the homes were minimized, through smaller hallway space and eliminating foyers, while still providing for maximum usable space.

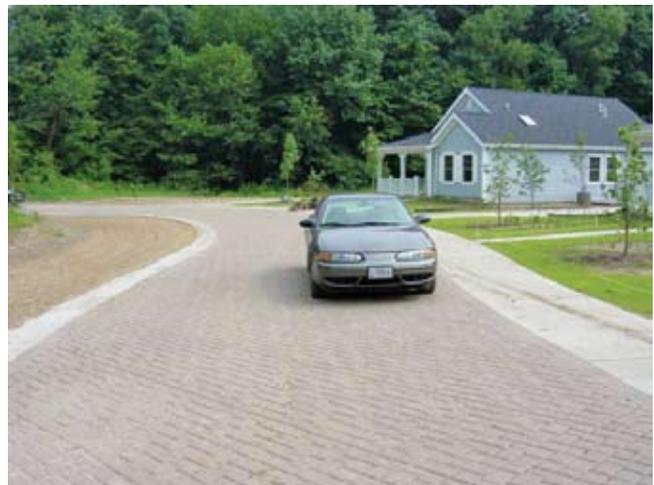
*Reduced imperviousness*

ing surface. The street's three-foot depth subbase is composed of a bottom layer of road-grade gravel and crushed concrete overlain by coarse grained sand to help facilitate stormwater infiltration. The earth at the bottom of the subbase is graded with a slight slope toward the central bioswale to assist with drainage during very heavy precipitation events.

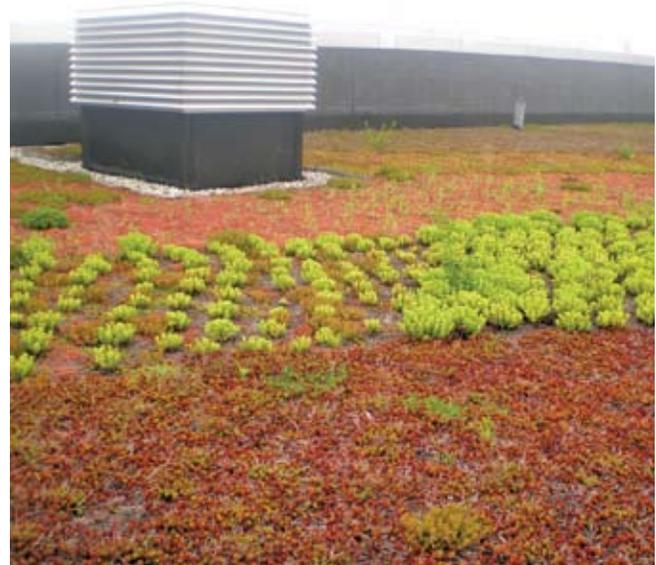
*Vegetated Roof at Lawrence Technological University*  
Source: Lawrence Technological University

The building’s 10,000 square-foot living vegetated roof is created with layers of insulation, roof membrane, drainage fabric, and a four-inch granular composition that supports nine different species of sedum ground cover. About nine inches thick, the roof offers more effective insulation than traditional roofs and expands and contracts with seasonal changes. It is expected to last about 40 years, more than twice the lifespan of traditional materials.

The vegetated roof also controls and reduces stormwater runoff. With normal rainfall, about 60 percent of the water will be absorbed by the roof while the remainder drains into a 10,000-gallon underground cistern to be used as “gray” water for flushing toilets and for irrigating the campus quadrangle. The weight of the roof is estimated to be 10 to 12 pounds per square foot with a saturated weight of 15 pounds per square foot.

The Hydrotech Garden Roof Assembly is an extensive roof that includes the following vegetation:

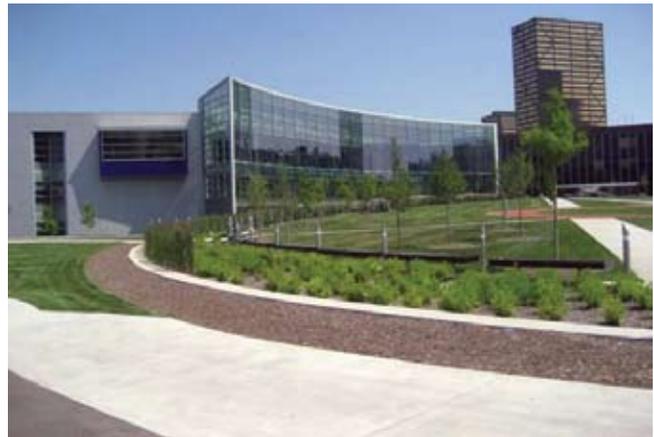
*Bioswale at Taubman Center, LTU Campus*

A circular bioswale, approximately 725 linear feet was installed around the campus quadrangle. The width of the bioswale varies from eight to 15 feet. The pre-existing soil consisted of clay with minimal topsoil. A system of weirs, tile fields (composed of material made of volcanic ash), and long-rooted grasses and trees will prevent 60 percent of the rainwater that falls on the adjacent campus quadrangle from running into the Rouge River as part of a regional effort to control stormwater drainage and improve the water quality and biodiversity of this portion of the Rouge watershed. This bioswale of vegetation will naturally purify the water by filtering out pollutants commonly found in snow and rain.

The capacity for the bioswale to capture stormwater runoff was designed for the 10+-year storm event — designed to flood with holding capacity exceeding 10-year event by backing up into the bioswale — essentially a long detention pond. Plants evapotranspiring coupled with free draining soils drain off surface water within 24 to 36 hours. Check dams positioned approximately 30 feet on center through more sloping zones

The upper 18 inches of soil within the bioswale is loamy sand amended with sphagnum peat moss for organic content and pH, covered with shredded hardwood bark mulch. All site subgrade soils were decompacted to a depth of 24 inches following construction operations, including in the bioswale, and prior to finishing landscape soil placement. The operation was performed in order to maximize porosity of subsoils for stormwater infiltration and to foster plant and tree health in the bioswale and all general landscape areas.

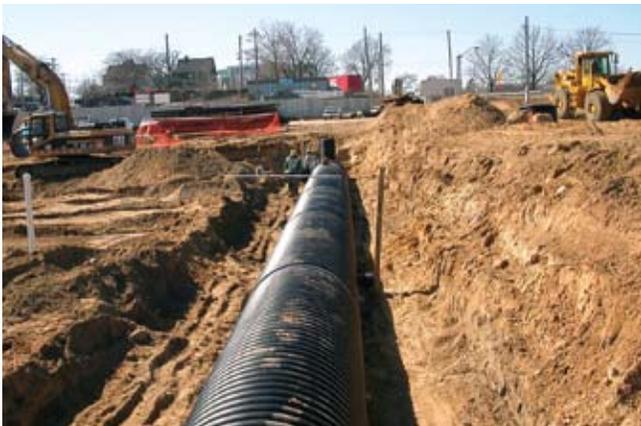
*Subsurface infiltration system*

The subsurface infiltration system is sized for the 25-year rain event. The area beneath the park will store 8,950 cubic feet of stormwater; the area along the east side of the site will store 6,774 cubic feet of stormwater. The subsurface stormwater system used the sandy soils and allowed for groundwater recharge, filtration of the stormwater, and eliminated the stormwater connection to the city's storm sewer system. The local rainfall information was reviewed and analyzed to determine the amount of storage necessary to collect adequate supply of rainwater for irrigating the development park area onsite. Using this system, the irrigation system for the development park area was not required to have a separate connection to the city's water system.

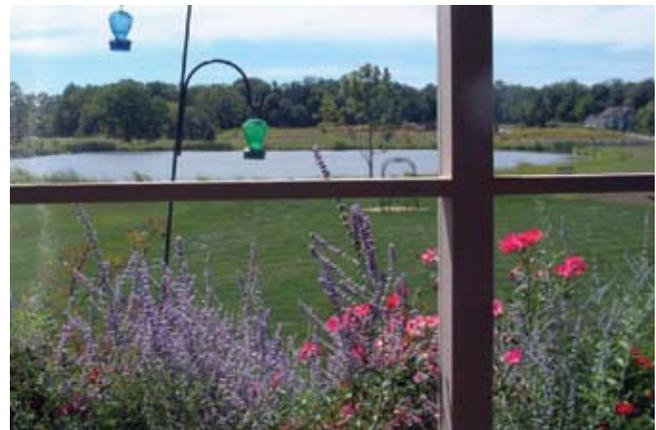
*View of wetland*

Sensitive areas — existing wetlands and very hilly areas — were preserved. Hilly areas include a change in topography of 20 feet over the 400-acre site. Existing wetlands are maintained by a buffer of greater than 75 feet of vegetation that is not mowed. This vegetated buffer reduces erosion in these areas by providing infiltration for stormwater runoff.

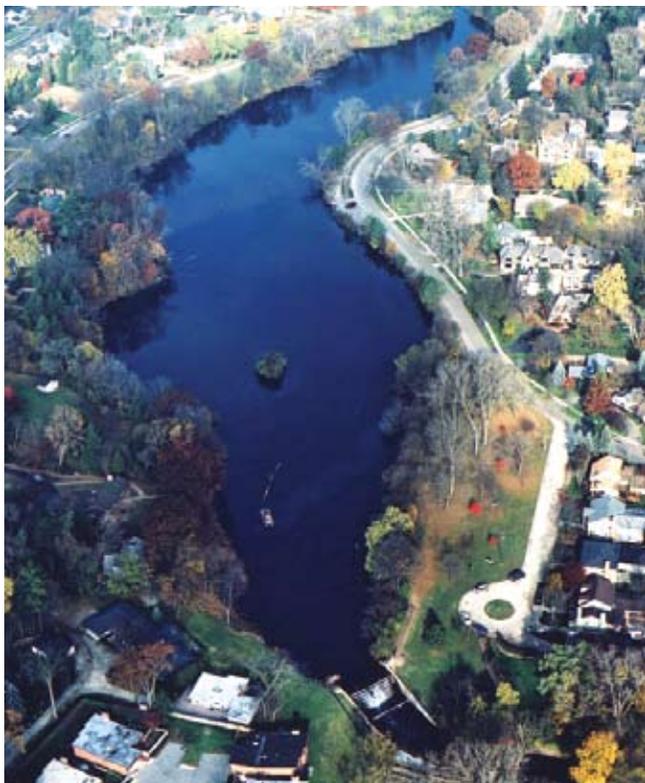
*Aerial view of Quarton Lake*

Dredging of 30,000 cubic yards of soil was performed which was dried in sediment bags and sent to a Type II landfill. In order to gauge the impacts of the dredging, a lake assessment (including monitoring of fish species, fish habitat, dissolved oxygen, and nutrient levels) was performed prior to dredging. The purpose of the dredging was to increase dissolved oxygen levels and improve phosphorus levels found in the lake sediment prior to dredging. Since the lake has been dredged, nutrient levels and dissolved oxygen levels have improved.

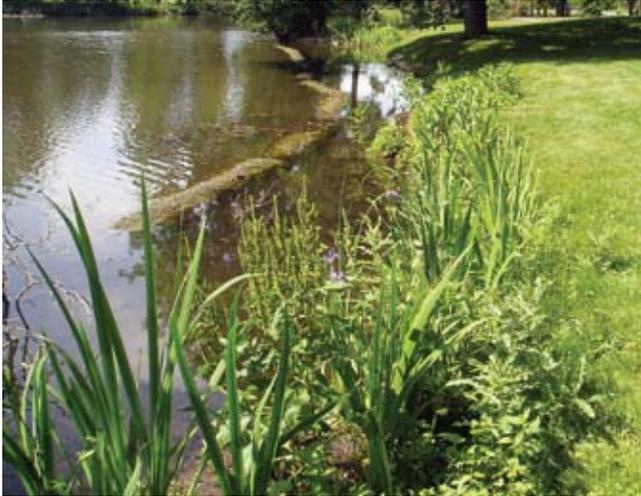
*Native vegetation for streambank stabilization and runoff infiltration*

The stabilized buffer area surrounding Quarton Lake has a width of 10 to 50 feet. Invasive plants, including common buckthorn and Japanese barberry were removed from this area for one year. Stabilization activities included installing coir logs on the east and west shorelines and stone terraces on the east and west sides of the lake. A total of 3,500 native plant plugs and 2,000 square yards of fescue and ryegrass seed mix were installed in this area. The native plants included serviceberry, viburnum, common arrowhead, common rush, sedges, and irises.

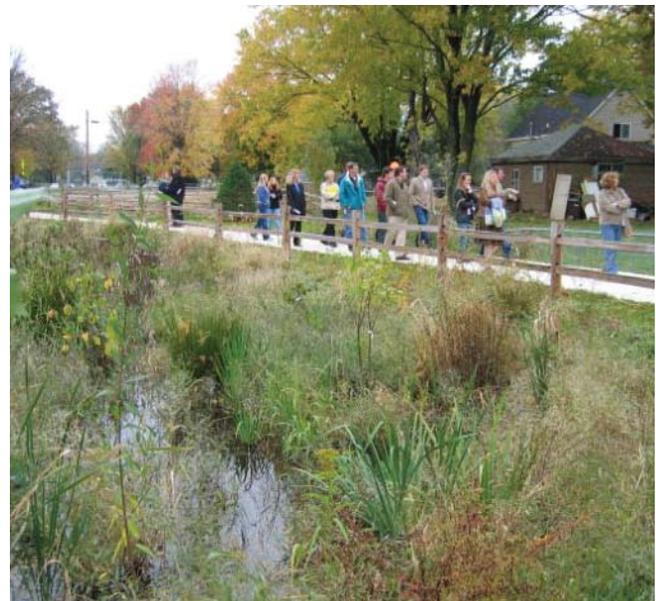
*Towar Drain neighborhood*

More than 150 individual rain gardens were constructed throughout the project, ranging from 100 square-feet, to areas larger than 2/3 acre. The main conveyance system consisted of small concrete pipes in the roadways that accepted the stormwater from the ditches and rear yards. This project is believed to be the largest urban retrofit of a stormwater system ever performed in the United States and the largest using rain gardens as the primary function to manage stormwater. It is the largest LID project ever performed under the Drain Code in Michigan. Maintenance costs are variable, since activities will be more intense in the initial years after construction is complete and until native species are fully established. Once established, costs are expected to decrease substantially.

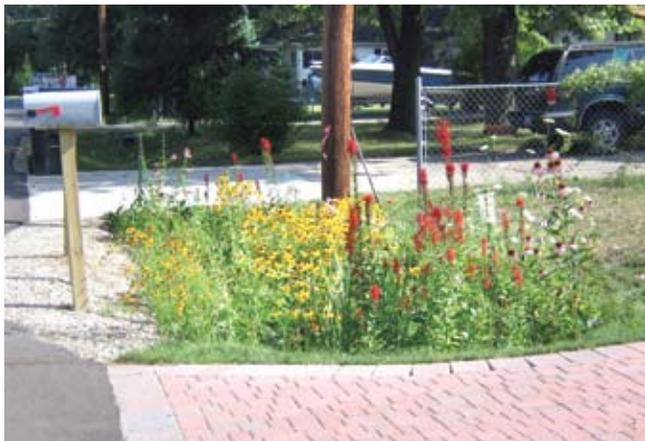
*Rain garden one year after establishment*  
Source: Fitzgerald Henne and Associates, Inc.

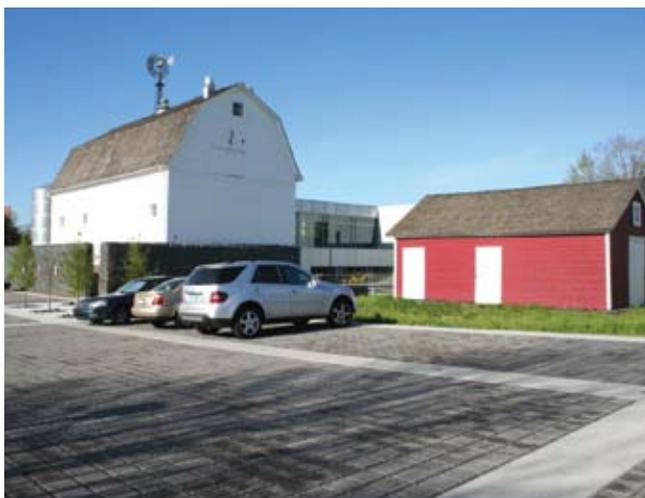
*Porous pavers*  
Source: Conservation Design Forum, Inc.

The parking lot is constructed with interlocking concrete pavers that have gaps filled with crushed stone and underlain with open-graded gravel. This porous paving system allows the water falling on its surface to be cooled, filtered, and infiltrated into the ground. Overflow water is directed to the bioswale systems.

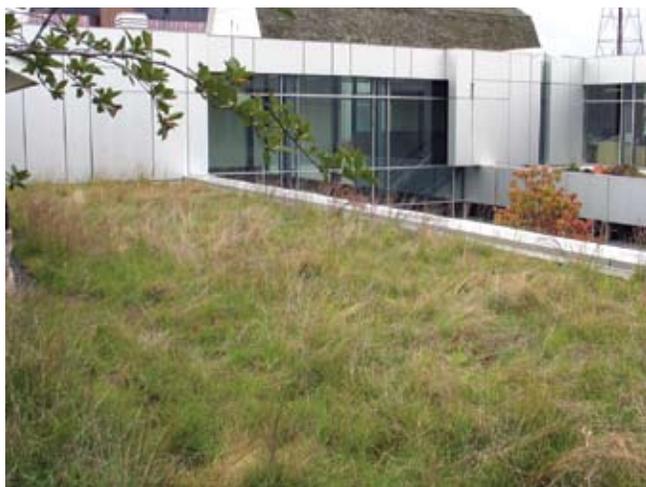
*Vegetated roof with meadow grass*

The portion of the roof surface that is at-grade (3,213 square feet) is established with a green roof using a mid-range grass planting mix. Rainwater from the upper portions of the roof is directed into the green roof, where it is cooled and used. Overflow water is then directed to the lower constructed wetland/pond (see below). Surplus rainwater is stored and reused to irrigate the green roof during periods of drought.

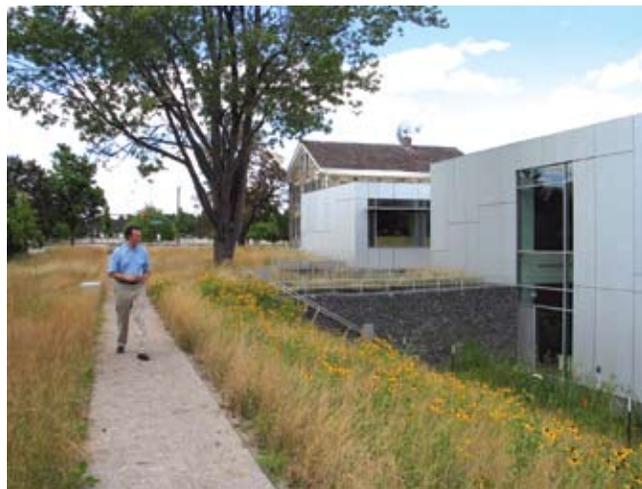
*Native landscaping prairie mix*

The entire site was planted with a range of native and adapted grasses and flowering perennials (primarily prairie species) that thrive without supplemental water once established. The landscape was organized into ornamental edges, panels, and zones to address views, programming, and the suburban and historic context of the site. The landscape is managed as a natural system and, where feasible, existing trees were retained. Since controlled burning is not permitted in this area, the landscape was designed with a hybrid native/adapted plant mix that will thrive with minimal input once fully estab-

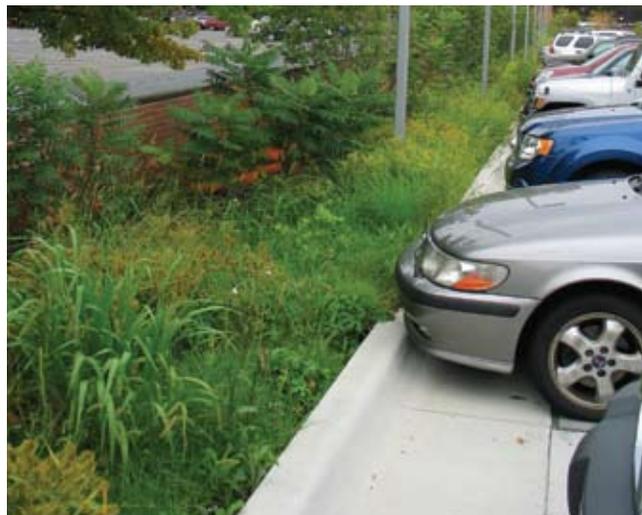
*Bioswale along parking lot*

Surplus rainwater is directed to a bioswale system. The bioswale is constructed with amended topsoil, underlain with stone, and planted with deep-rooted grasses. The bioswale slows and further cleanses and cools the rainwater, allowing more of it to return to the atmosphere in the form of evapotranspiration. The bioswale system then overflows into the city storm drain only in the heaviest rain events and when the ground is saturated.

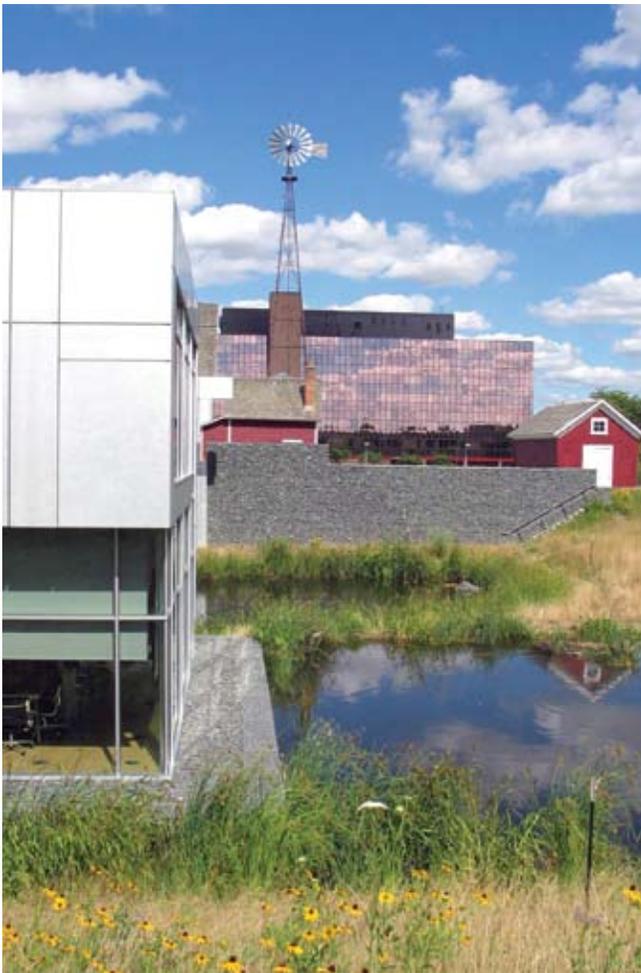
*Wetland along building*

The lowest portion of the site was developed as a constructed wetland pond. It is a lined basin meant to have a permanent water surface, with a planted wetland fringe mimicking a native system. Rainwater that overflows from the roof and portions of the site are directed to this pond. If the water level rises more than six inches, surplus water is drawn into the cistern for future reuse. If the water level draws down during dry periods by more than six inches, water from the cistern is allowed to flow back in. This keeps a fairly constant water level to maintain a high quality wetland habitat and also allows the pond to be part of the stormwater management system.

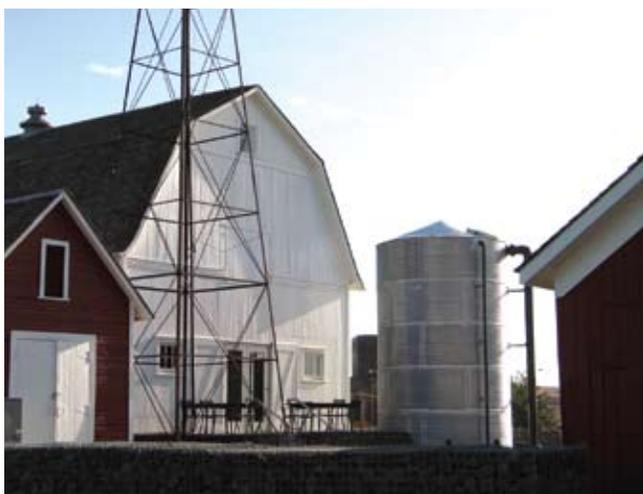
*Cistern at Kresge Foundation*

The entire landscape thrives without the use of potable water. Rainwater is harvested, treated, and stored in a cistern to provide water for the constructed wetland and supplemental water for the green roof system. In order to optimize this system, a water budget was developed and used as a design tool. The amount of water potentially generated from rainwater (supply) was compared with water needs (demand). An analysis of the water budget throughout the year led to refinement of the design and sizing of the water landscapes and storage elements.

When the water level in the created wetland drops two inches below normal water level, the pond is refilled to the normal water level using water in the cistern. The required volume to refill the two-inch drawdown is approximately 6,600 gallons. The 18,000 gallon cistern has sufficient volume to refill the drawdown more than 2.5 times. The average monthly water supply exceeds the average monthly water demand by more than 50 percent. The cistern has sufficient volume to supply more than three weeks of irrigation and refill the created wetland water feature.
